Experimental Analysis of a Gantry Crane of a Shell Structure

Gantry cranes of the shell structure are used in Polish steel industry much less than other gantry crane types. Those gantry cranes characterized by increased susceptibility to mechanical vibrations, resulting in greater sensitivity to the formation of fatigue cracks. In this work, measurements of strain gauge bridge deformation of the shells, for which periodically conducted non-destructive testing revealed the presence of numerous fatigue cracks mainly in the area of the under rail beams. Performed periodically repair and reinforcement of the crane did not eliminate the problem of the formation of the subsequent fatigue cracks. The analysis of the dynamic operation of the bridge, in combination with FEM calculations carried out showed stresses exceeding the limit value due to the fatigue phenomena. The results of dynamic analysis can serve as a basis to perform more accurate analysis of the fatigue life of the most intensive areas of the bridge.

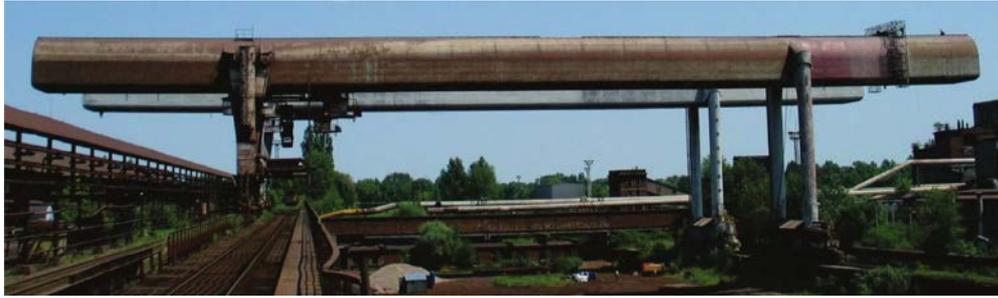
Gantry cranes of the shell structure [8, 10] are characterized by very high stiffness and slenderness, their disadvantage is several times lower lifting capacity, compared to the truss structures of comparable sizes, as well as increased susceptibility to mechanical vibrations. Considerations were performed for 350 kN charging gantry crane, operated in one of the Polish steel mills – Fig. 1. For the crane carrier element is a span length of 133 m of the shell structure made of sheet steel reinforced by longitudinally and transversely extending ribs.

FIG. 1. Charging crane of a shell structure.

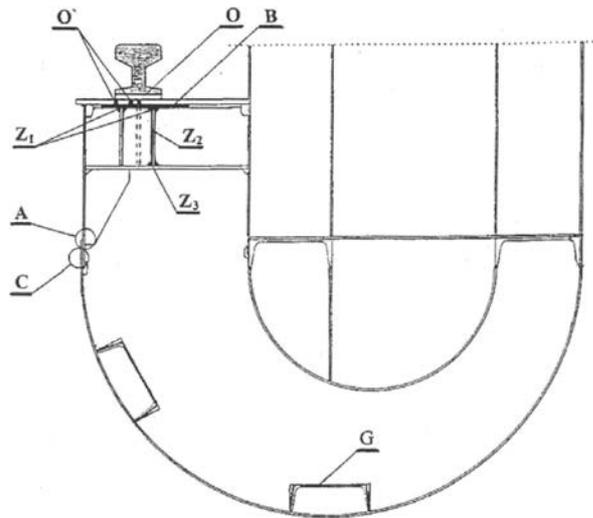
- “A” type – crack of the welded joint in the lower portion of the rib of transverse ribs under rail beam,
- “B” type – crack of the weld connecting the upper shelf ceiling beam with a horizontal shell under rail beam,
- “C” type – vertical crack of the welded joint under rail beam and shell, located between the ribs of the under rail beam,
- “O” type – plate crack under the rail in the direction of the axis of the rail, near the ribs,
- “O’” type – plate crack under the rail parallel to the axis of the rail,
- “Z₁” (“Z₃”) type – weld crack parallel to the axis of the rail, the transverse ribs or rib frames,
- “Z₂” type – vertical joints crack, ribs transverse ribs or frames,
- “G” type – longitudinal butt weld crack (C-section 300).

FIG. 2. Location of the detected cracks of the crane beam.

Made of non-destructive testing [9] revealed a number of areas of cracks, usually on a fatigue nature and other structural damage to the crane. The greatest severity of fatigue cracks were found for under rail beams of the carriage, for which the identified types of damage are illustrated in Figs. 2, 3 and 4.

In addition to occasionally detected cracks “A”, “C” and “G”, for different series of tests were found in total: 42–47% “Z” type cracks, 13–42% “O” cracks type and 8–25% cracks “B” type of the total number of detected cracks. Also in other areas of the crane construction fatigue cracks have occurred, the most serious of which were detected for the shell over the long support leg – Fig. 5.

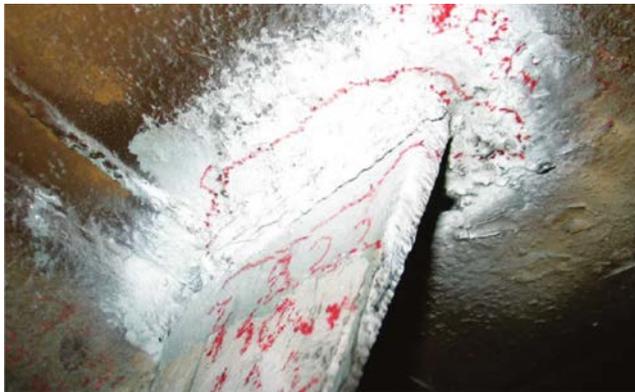
FIG. 3. Crack of the crane beam detected by the magnetic-powder method type “Z₁” joint 140 mm long.

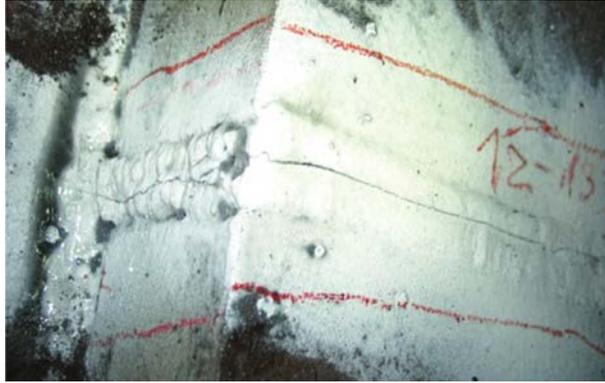
FIG. 4. Cracks weld of the crane beam stringer type "G" detected by the magnetic-powder method.

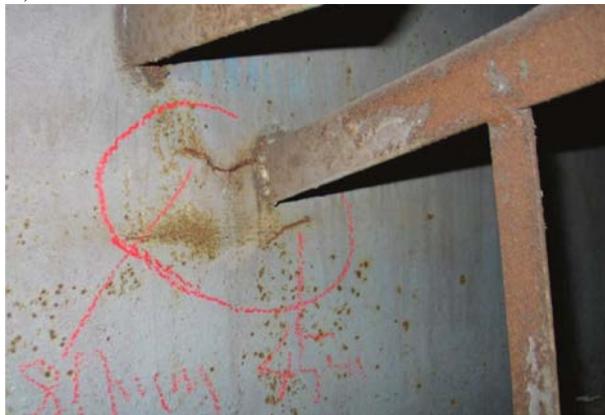
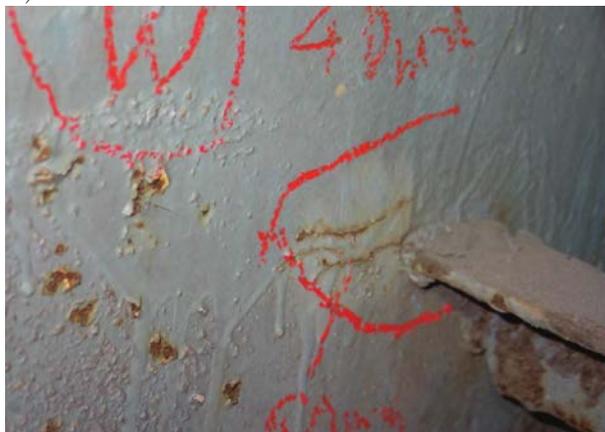
FIG. 5. Shell cracks above the long support: a) western side of the bridge – 80 mm and 45 mm long, b) eastern side of the bridge – 80 mm and 45 mm long.

Sample results of reduced stresses obtained in accordance with the hypothesis Huber-Mises, for the span and under rail beam for one of the variants loads are shown in Fig. 8, which also marked the locus of shell cracking shown in Fig. 5, which appeared in place of the notch-induced welding the shell brackets made of L-section, not included in the analysis of the FEM.

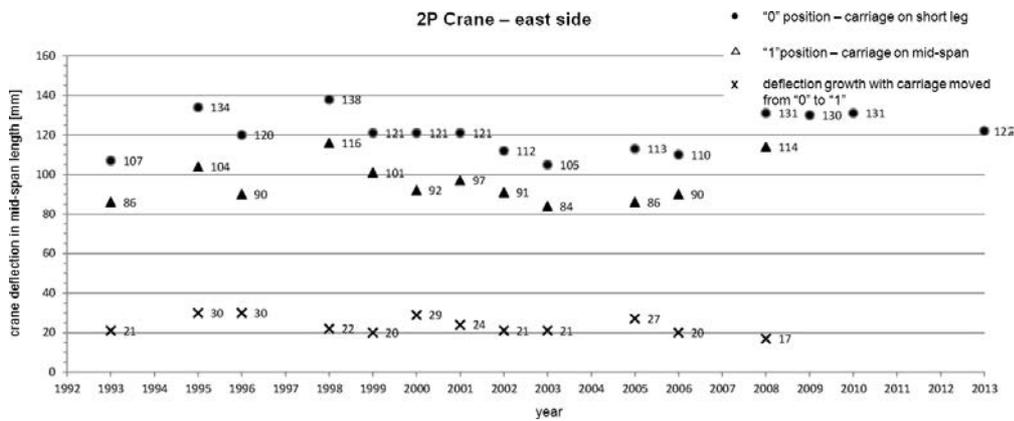
a function of measurement date was shown in Fig. 6. Analysis of measurement results which are presented in Fig. 6 shows that after stabilization of the shape of the beam after the reinforcements after 1993 (years 1993–1996) there is a trend to a slow decline in the value of the deflection to 2003 (results for the years 1998 to 2003) and after the subsequent reinforcement and repair increase in the value of the deflection can be observed registered in the measurements carried out after 2005. Occurring throughout the observation period fluctuations in the value of the deflection are probably connected to: the made cracks repairs in beams, thermal conditions of the measurements, with varying location of the bridge on the length of the track during the course of the next series of measurements as well as other factors such as, for example impact of wind on the structure when conducting geodetic measurements.

FIG. 6. Results of deflection measurement in the middle of crane's span on east side [1].

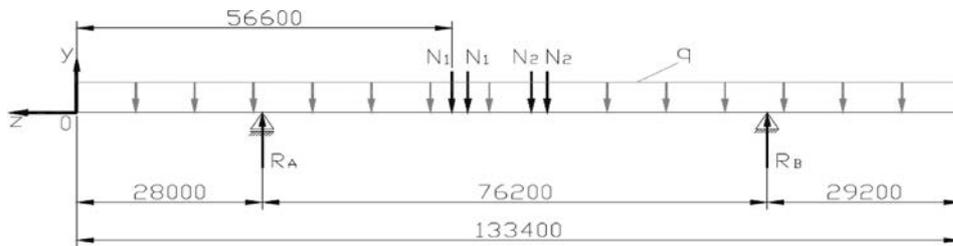
For the discrete model of the crane structure, a total of 17 load cases were examined [4]. FEM analysis [6] showed that for the most unfavorable loads variants of the crane construction, extreme values of shear forces for the span are present in the support area, while the extreme values of bending moments in the support area and in the middle of the span length between supports –

Fig. 7. These areas are consistent with the areas of greatest severity of fatigue cracks in the under rail beams.

FIG. 7. FEM analysis – load variant 2: beam model with carriage on 56.6 m.

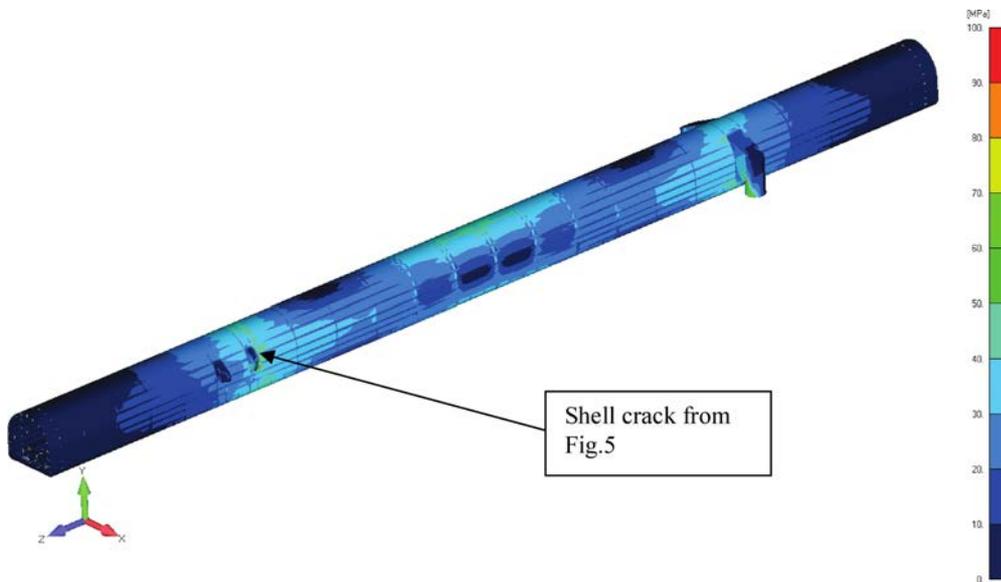
FIG. 8. FEM analysis – distribution of the reduced stresses in the span – load variant 2.

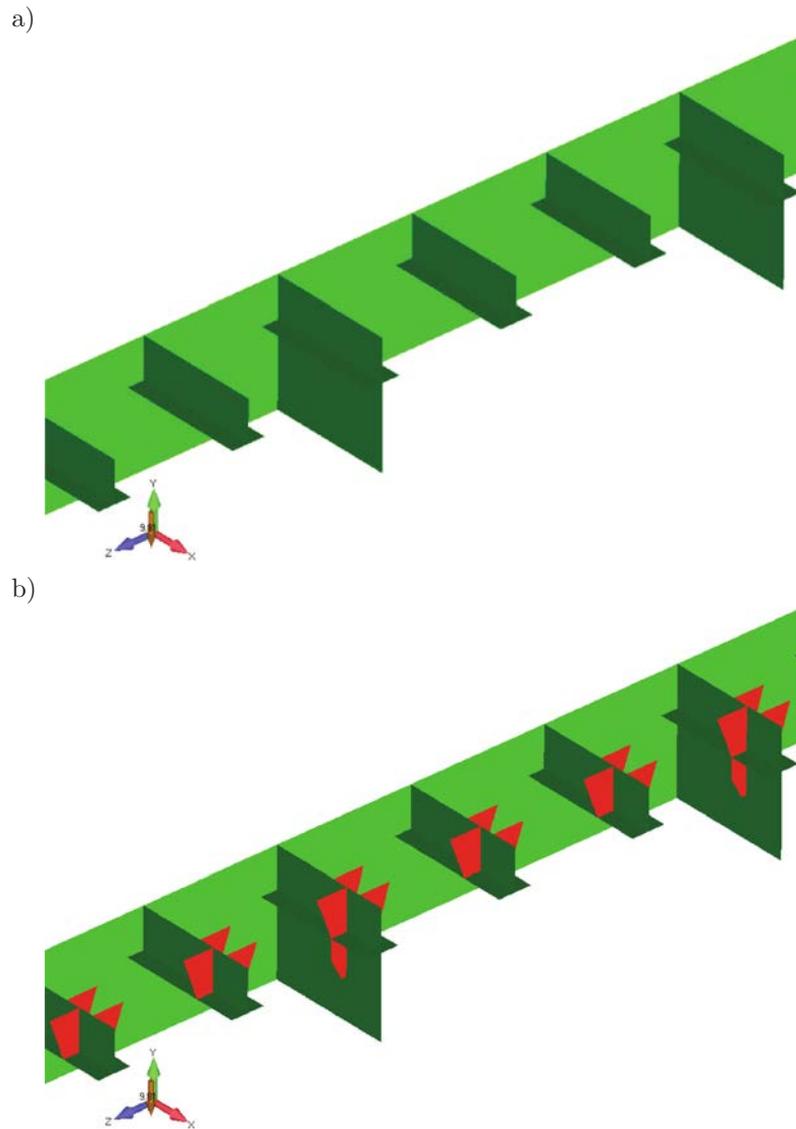
Under rail beam, due to the opening of a fatigue crack was repeatedly repaired during operation, and then reinforced with additional ribs. In order to evaluate the effect of the reinforcements, a comparative analysis of beams without reinforcement – Fig. 9a and beams with reinforcements – Fig. 9b were done. In

FIG. 9. Inner structure of under rail beam: a) original, b) with additional ribs.

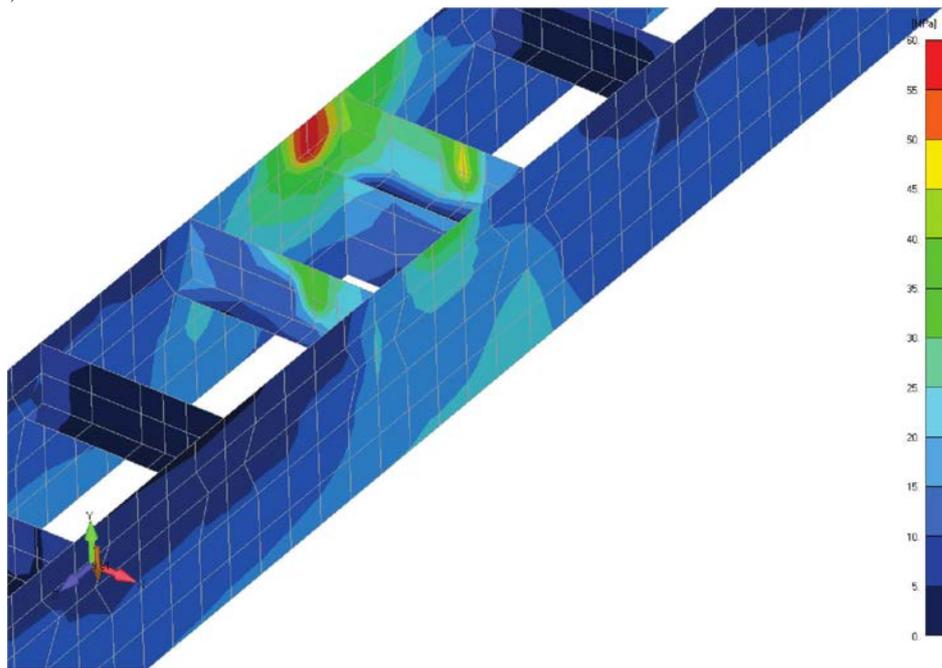
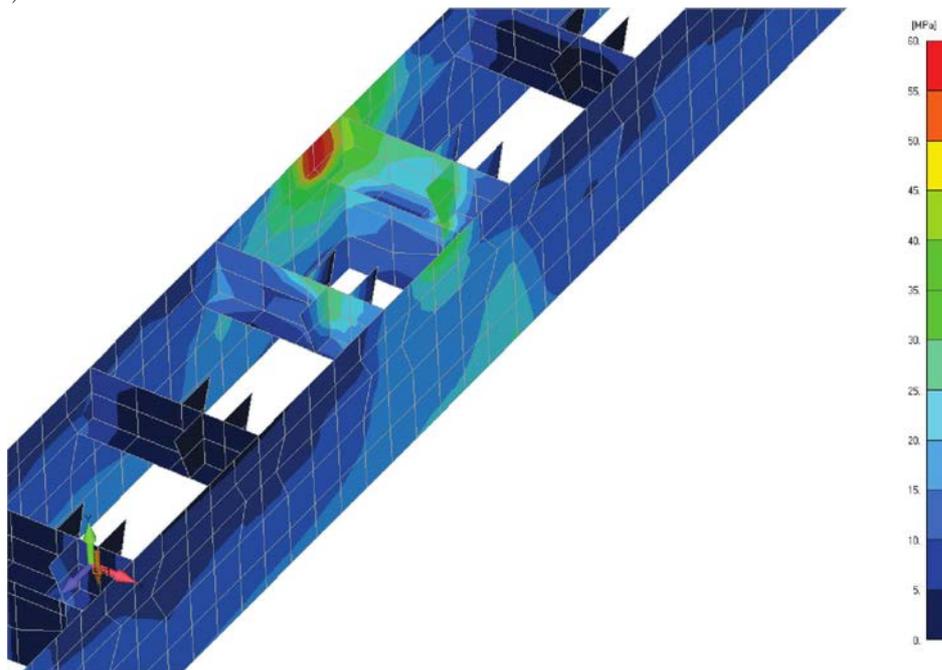
Fig. 10 shows the distribution of reduced Huber-Mises stresses and the values obtained for selected areas of the structure are summarized in Table 1 (values shown in brackets after the application of reinforcing ribs). Extreme reduced stress values for under rail beams without reinforcements, amounting to 65 MPa were obtained for the area of fillet welds cracks type “B” and “Z”. The use of additional reinforcing ribs locally resulted in a reduction of stress cracks in the area “B” and “Z” about to 30%.

FIG. 10. FEM Analysis – distribution of the reduced stresses in the under rail beam:
a) original, b) with additional ribs.

Extreme reduced stress values for under rail beams before making reinforcements amounting to 65 MPa was obtained for the fillet welds type “B” and “Z” cracks area. As the source of “O” type cracks is often detected their neighborhood with cracks “B” and “Z”. The use of additional reinforcing ribs locally resulted in a reduction of stress in the area “B” and “Z” cracks of approx. 30%.

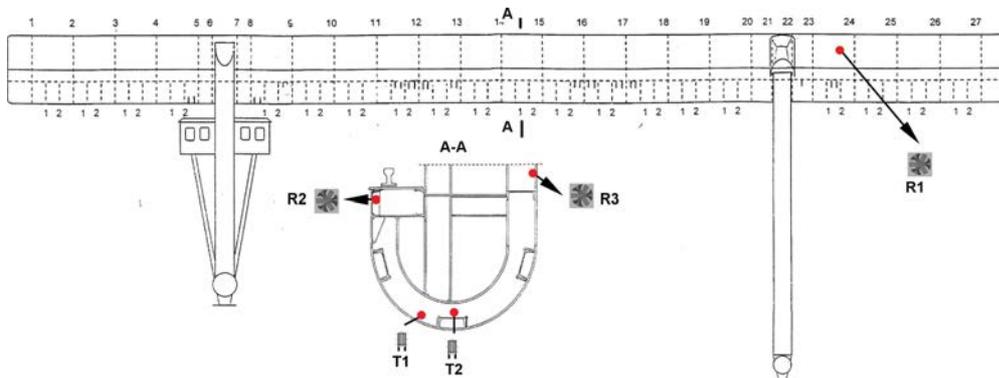
Arrangement diagram strain gauges rosettes R2, R3, T1, T2 in the middle of the span length in the area under rail beam between the ribs Number 14 and 15 on the western side of the bridge, and on the shell on the western side of the bridge behind long support leg mounted strain gauges rosette R1, shown in Fig. 11. Figure 12 shows mounted on the shell of the bridge rosette R1 and single strain gauges in the area under rail beam T1 (mounted on the shell) and T2 (mounted on C300 profile)

FIG. 11. Arrangement diagram strain gauges.

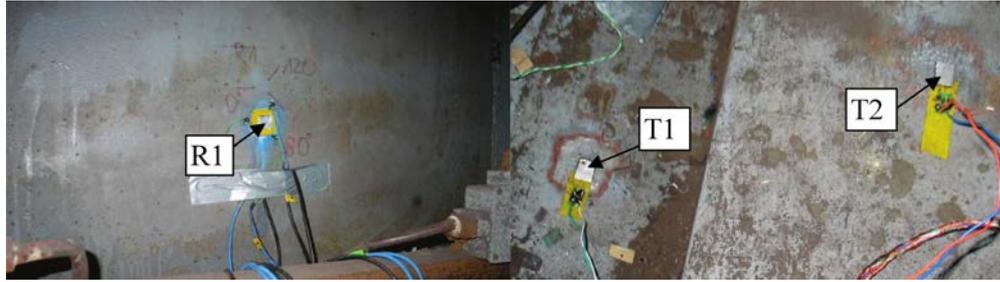
FIG. 12. Rosette R1 and single strain gauges T1 and T2 mounted crane structure.

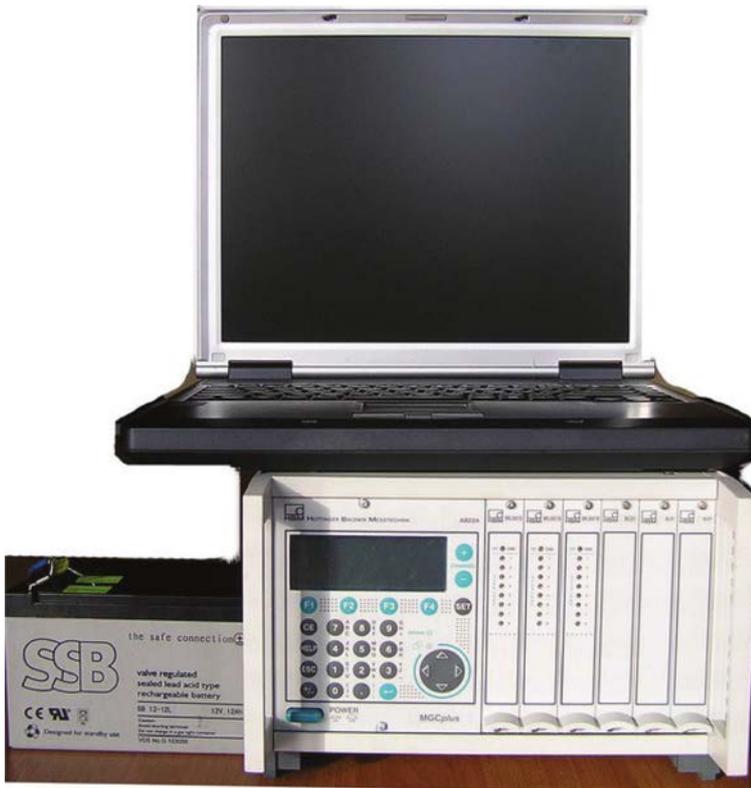
Measurements are taken with an amplifier HMB MGCplus utilising resistance or induction sensors. The bridge is supplied from gel batteries 12V-12Ah and the entire circuit is connected to a portable computer (laptop) supported by the professional programme “Catman” (HMB) to record the measurement data. The measurement equipment is shown in Fig. 13.

FIG. 13. Measuring equipment.

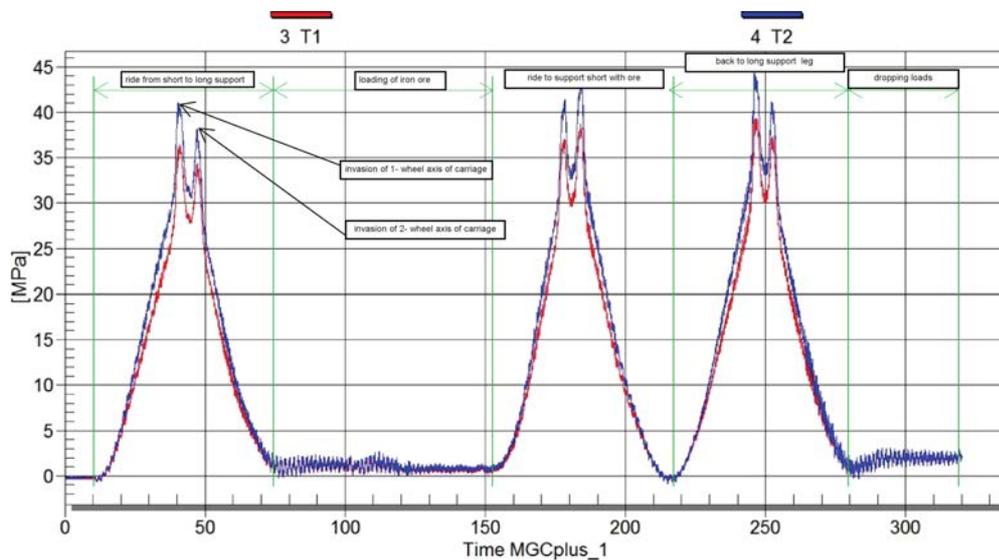
The maximum measured stress values were recorded during the second measurement cycle on C300 profile in the lower part of the rail beam where the strain gauge mounted T2 and on the bottom of the shell where the strain gauge mounted T1.

Figure 14 show graphs of stress for the second cycle registered by the single strain gauges T1 and T2 and in Fig. 15 show graphs of reduced stresses for the second cycle registered by the strain gauges rosettes R2, R3, R3.

FIG. 14. Figure stress σ_1 at the time of the second cycle registered by the T1 and T2.

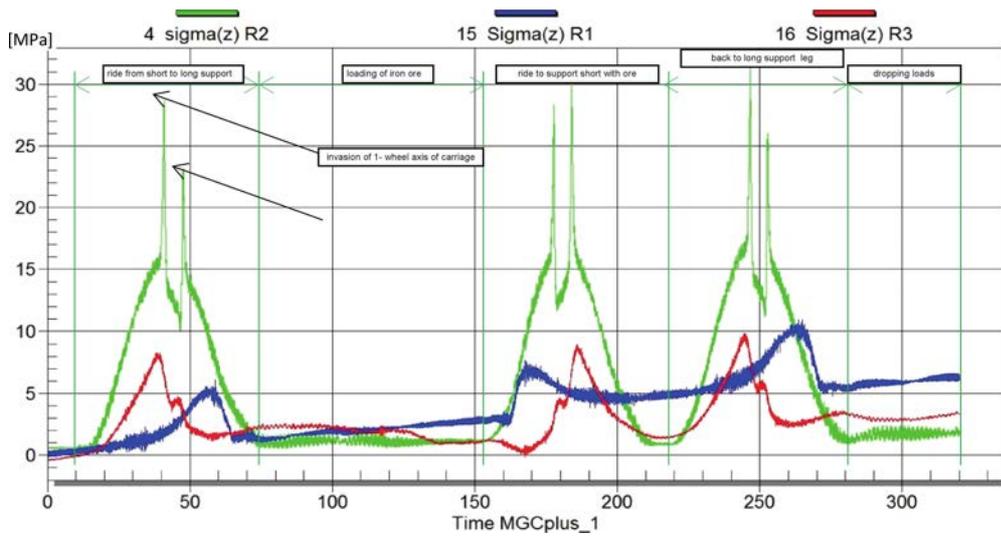
The greatest stress were registered by the rosette R2 (Fig. 15) located under the rail beam and amounted to about 31 MPa and the rosette R3 stress on the shell of the bridge were about 10 MPa.

FIG. 15. Figure reduced stresses σ_z during the second cycle registered by the R1, R2 and R3.

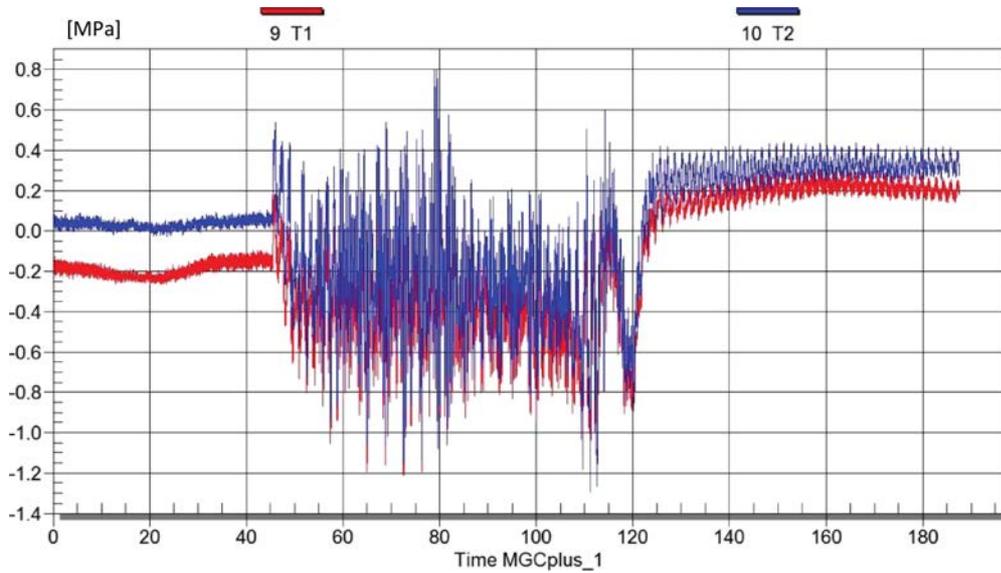
While driving bridge – the fourth cycle, the strain gauges T1, T2 observe double-sided asymmetrical cycles a small amplitude change of stress of about 1.5 MPa shown in Fig. 16. and the values of reduced stress for R1, R2, R3 are a maximum of 4 MPa shown in Fig. 17.

FIG. 16. Figure stress σ_1 at the time of the fourth cycle registered by the T1 and T2.

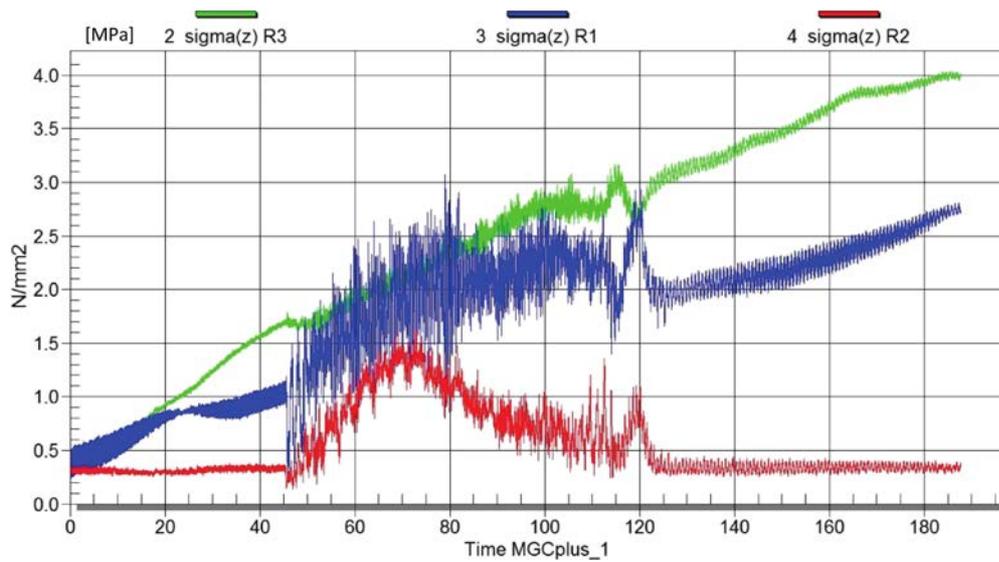
FIG. 17. Figure reduced stresses σ_z during the fourth cycle registered by the R1, R2 and R3.
