## Research Paper

# Effect of Initial Scratch on Ship Bottom Plate Corrosion Rate and Structural Crashworthiness in Grounding Incidents

**Keywords:** scratch; ship grounding; severe corrosion; finite element analysis.

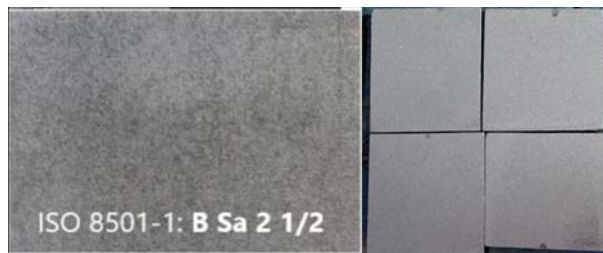
FIG. 1. Visual inspection of the material after the sandblasting process, according to ISO 8501-1 [28].

In the subsequent stage, each specimen was cleaned using a sandblasting procedure in accordance with the ISO 8501-1 guidelines [28]. Sandblasting was performed as a preparatory step before the application of protective coatings. Garnet abrasive material was used in this sandblasting process, with pressure maintained between 6–7 bar. To ensure consistent and accurate results, the distance between the specimen and the nozzle was kept within the range of 15–25 cm throughout the sandblasting operation. According to ISO 8501-1 [28], the blasting quality must be assessed through visual inspection to measure the SA level, as well as through roughness testing methods. The blasting procedure was conducted until each specimen reached a SA level of 2.5. Figure 1 shows a comparison of the SA levels, with the benchmark on the left side and the specimen on the right.

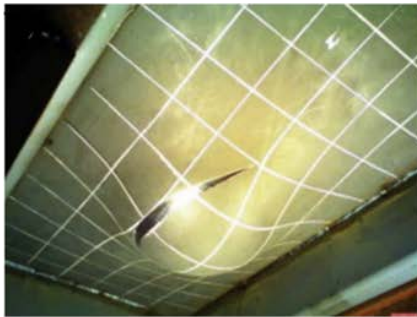
FIG. 11. Crack displacement in the grounding simulation:  
a) ALSOS and AMDAHL experiment [36], b) numerical simulation.

ther support this validation, the damaged contour of the plain plate exhibited similar patterns in both experimental and simulations results, as illustrated in Fig. 11. This reveals that the location of the crack in both the experimental and simulated results was found on the narrow sides of the plate.
