BEHAVIOUR OF STEEL-SOIL BRIDGE STRUCTURE MADE OF CORRUGATED PLATES UNDER FIELD LOAD TESTS.

PART I: STATIC RESEARCH

The way in which a single-span, flexible-structure bridge made from *Super Cor SC-56B* corrugated steel plates, located in Gimån on the Bråcke – Holm road (no. 716) in Sweden, was tested is described, and the results of the tests and static-strength calculations that serve as the basis for determining the quality and durability of the bridge and accepted it for normal service in view of its quite large effective span and prototypical character (the first bridge of this type in Scandinavia) are presented [1].

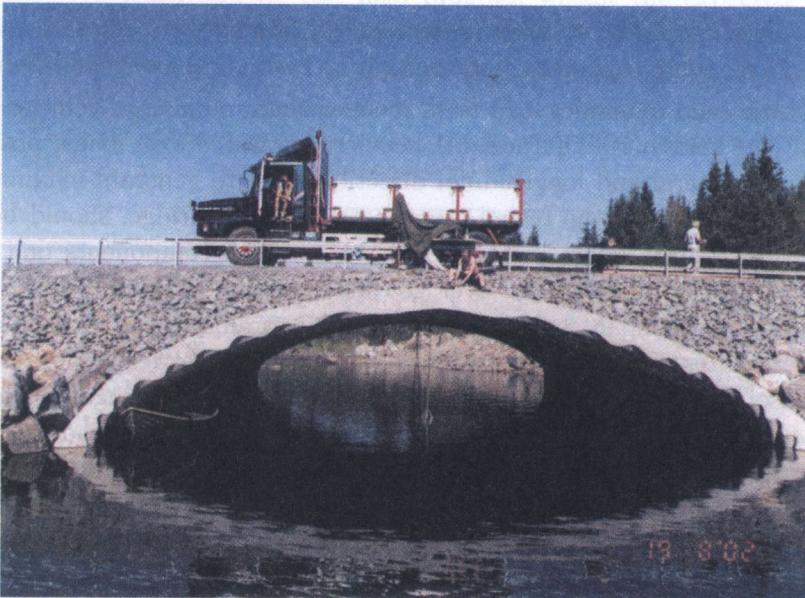
FIG. 3. Side view of bridge and Scania ballasting truck during tests (asymmetric load scheme I). Visible tripods for fixing displacement gauges.

As originally planned, three load schemes (Figs. 3-4), i.e., two asymmetric load schemes (the truck positioned at the protective barrier on the upstream side - scheme I or on the tailwater side - scheme III) and one symmetric (to the longitudinal axis of the bridge) load scheme (the truck positioned on the longitudinal axis of the roadway in such a way that its rear axle was located in the middle of the effective span length - scheme II) were used).

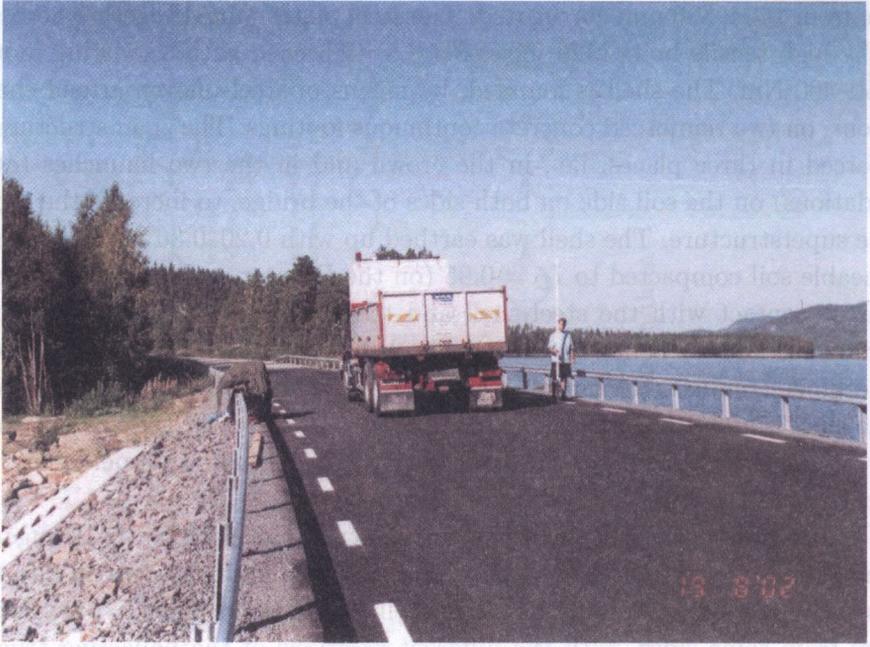
FIG. 4. Rear view of ballasting truck on bridge during tests (symmetric load scheme II).
