# STRENGTH ANALYSIS OF TYPICAL CONSTRUCTIONS OF KOEPE PULLEYS APPLIED IN MINING HOISTING INSTALLATIONS

Stanisław WOLNY, Bogusław ŁADECKI

AGH University of Science and Technology  
Faculty of Mechanical Engineering and Robotics  
Al. Mickiewicza 30, 30-059 Kraków, Poland  
e-mail: {stwolny, boglad}@agh.edu.pl

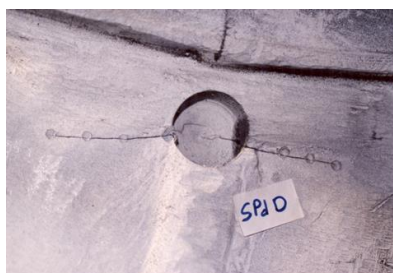
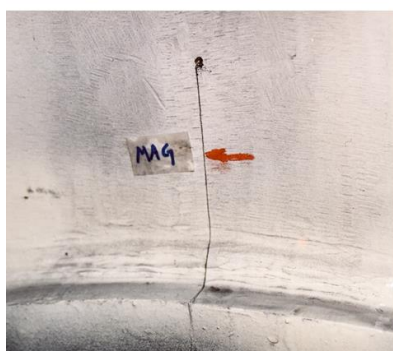
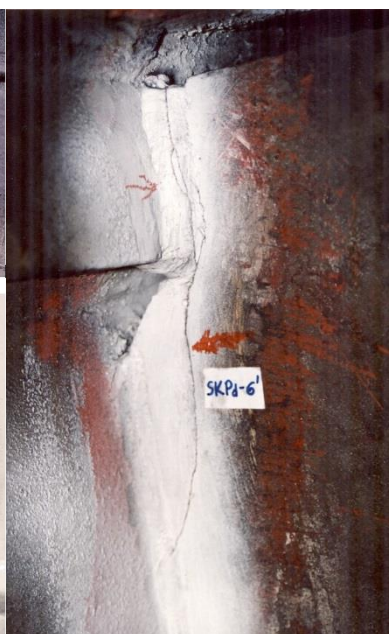
Fig. 2. Schematic presentation of the Koepe pulley with 'U' diaphragms: 1 – mantle, 2 – disk, 3 – hub, 4 – circumferential ring, 5 - diaphragm – a; fatigue cracks within a side disks zone: b – circumferential and radial cracks, c – crack in the zone joining the diaphragm 'U' with the side disk and hub [1]

In order to determine ranges, character and intensity of occurrence of fatigue failures of Koepe pulleys of two considered constructions: with diaphragms of a shape of U letter, or with two circumferential rings stiffening the mantel, used in the selected Polish mines, non-destructive tests were performed by means of the magnetic-powder and ultrasound methods. Performed investigations indicated an occurrence of numerous cracks. Examples of crack types for the pulley with ‘U’ diaphragms are shown in Fig. 2 [1,2], while for the pulley with circumferential stiffening rings in Fig. 3 [3].

The analysis of the FEM calculations indicates that the crack growth along line A-B (model MA) has no influence on the stress state and disk deformations. However, when the crack will grow to point D or E, it means when it will reach the side disk, its further growth will occur within the disk, causing failures illustrated in Fig. 2b.
