Assessment of Internal Damages in Sandwich Panels via Active Thermography

Key words: foam-core sandwich panels, internal damages, active thermography, quality control.

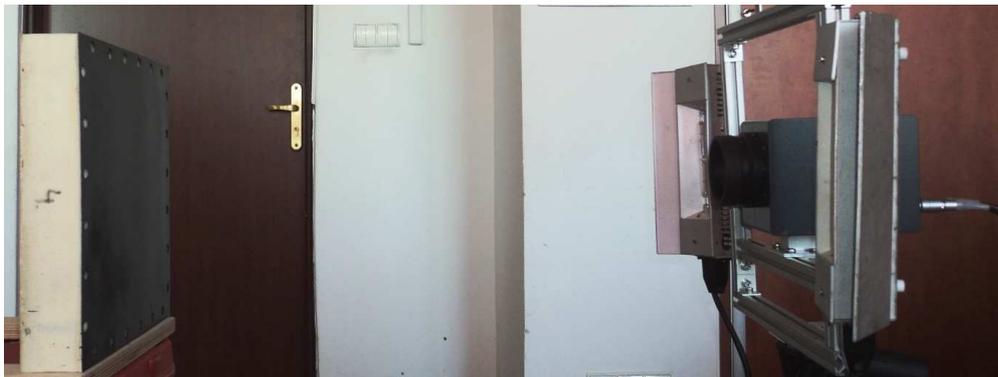
In order to ensure a good emissivity of surfaces of tested plates they were covered by black matt paint. The tests were performed using VarioCAM hr infrared camera, which was placed at the distance of 0.8 m from the tested specimens. The emissivity was defined as 0.9. The ambient temperature was measured and then set to 24°C. The heating pulse was induced by two 1000 W halogen lamps located on the opposite sides with respect to infrared camera on the aluminium frame and directed onto the surfaces of tested panels. A view of the experimental setup is presented in Fig. 4.

FIG. 4. Experimental setup.
